Project BRACER

Technical Report of the Remediation of the Biological Waste Pits Located Behind Building H-55, CFB Kingston, Ontario

Technical Report
DRDC Suffield TR 2003-034
April 2003

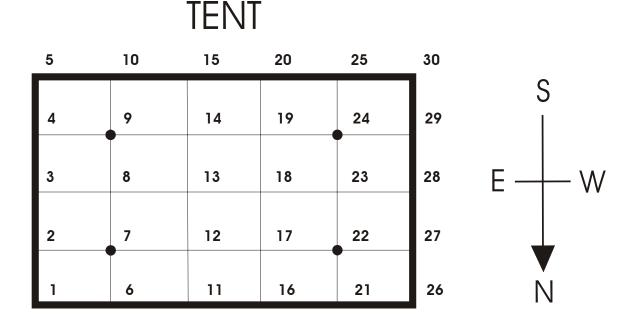
Survey Grid Reference

- 7. Inside the DRDC Suffield portable excavation structure, an alpha, beta and gamma survey was conducted each afternoon before lunch break and at the end of each day. The grid below depicts the four locations inside the tent where measurements were recorded.
- 8. All measurements were made using the ADM300C survey meter.
- 9. In summary, data indicated that no readings ever exceeded background levels.

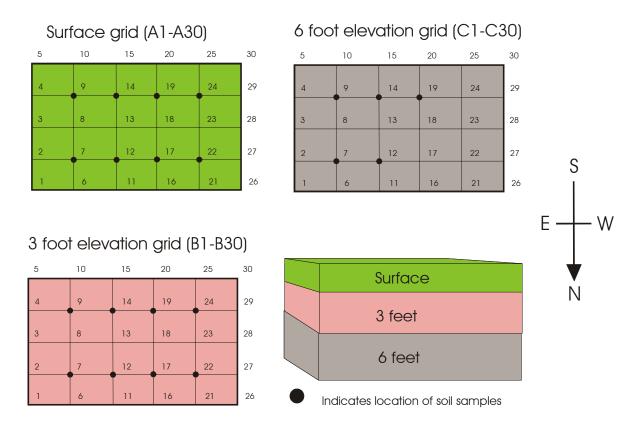
Figure 1 – Soil sample grid references

14. The following diagram indicates the location and elevation of each soil sample. Bedrock was close to the surface on the west end of the tent, allowing only 5 soil samples at the 6-foot mark. Eight samples at the surface and 3-foot mark were obtained.
